# **Results of Auger Analysis** **of** **ATLAS Pixel Chip Wire-bond Pads**

*K. Einsweiler, LBNL and D. Harris, CEA*

**Analysis performed by Charles Evans & Associates, Sunnyvale, CA**

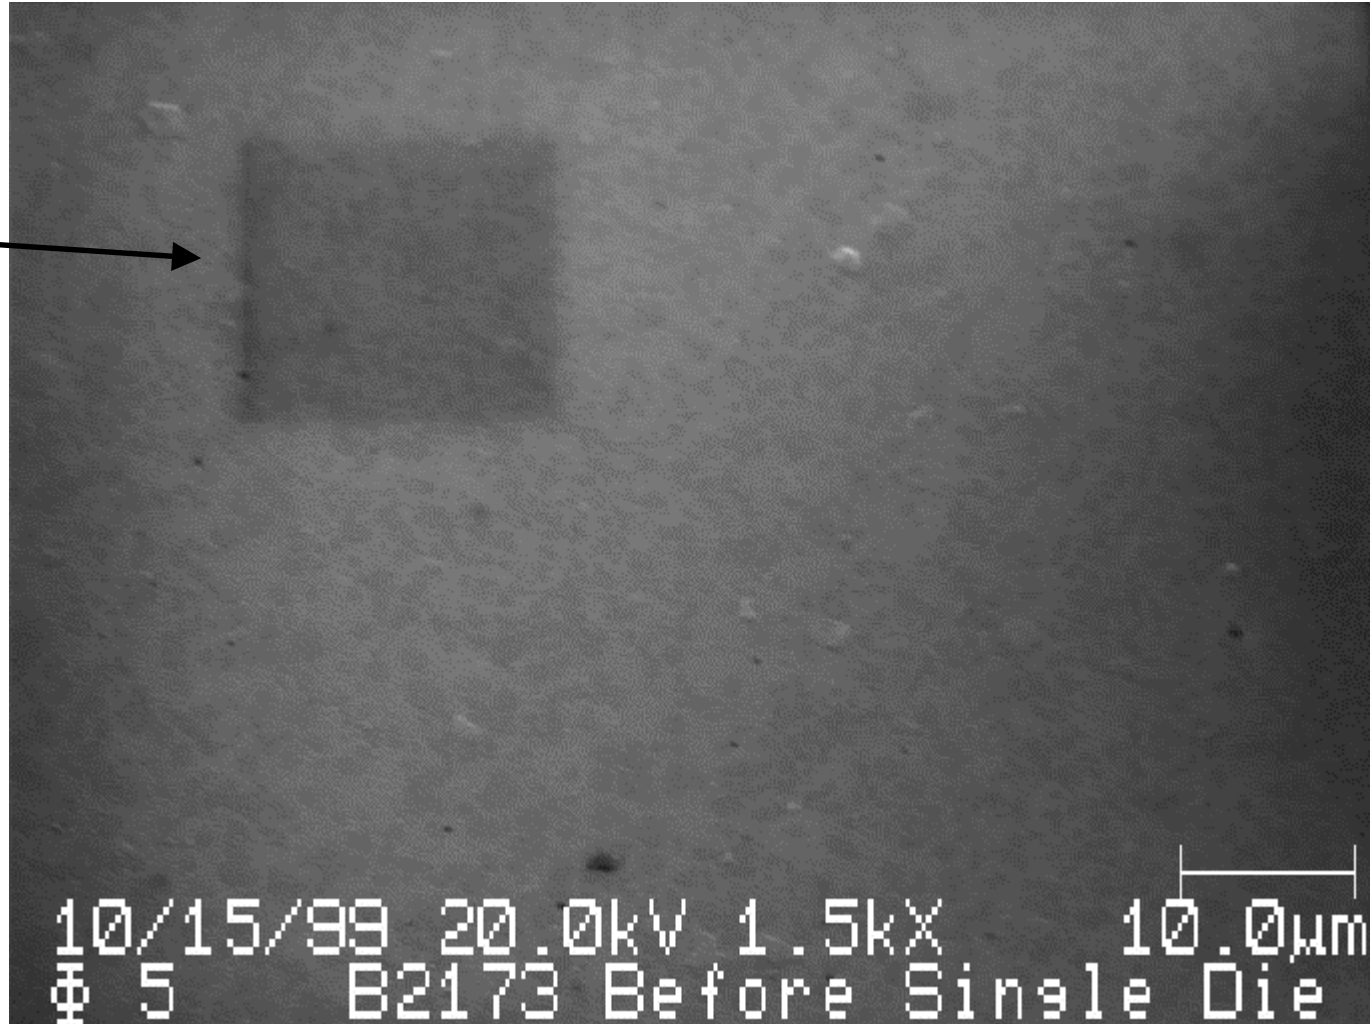
## Single Die Direct from Wafer

Region used  
in Auger  
analysis.  
Image  
recorded  
after analysis  
was  
performed.

- Depth profile shows presence of Al oxide layer of about 100Å thickness. This is seen as an O peak which disappears after about 100Å. Also, in the Al depth profile, the character of the peak is seen to change from “non-elemental” to “elemental” (displacement of peak and secondary shoulder appears).
- A small amount of F contamination is seen in the oxide layer. This is a typical residue of the plasma etch step used to make the openings in the passivation layer for the bond-pads (normally uses CF<sub>4</sub> or similar).
- Once the analysis passes through this Al oxide layer, there is pure elemental Al and nothing else.
- No other material is seen. This is a very normal bond-pad. Wire-bonding is usually successful up to Al oxide thicknesses of more than 200Å, so this would not present any problems.

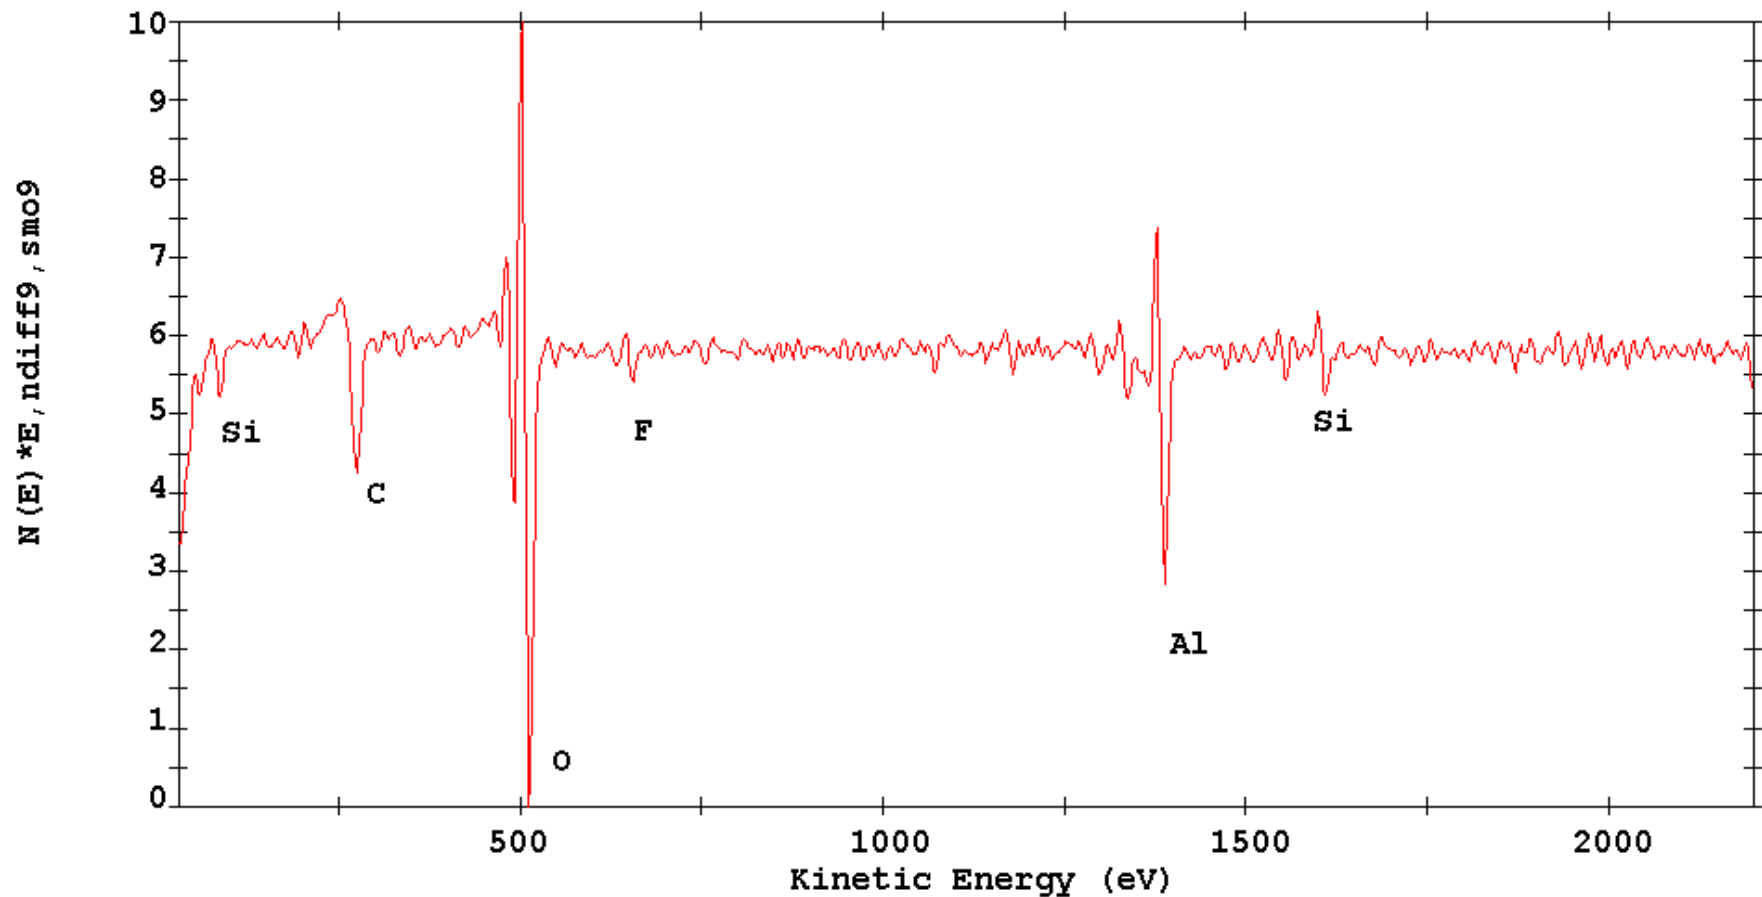
Initial full survey, used to define spectra windows to track during depth profiling.

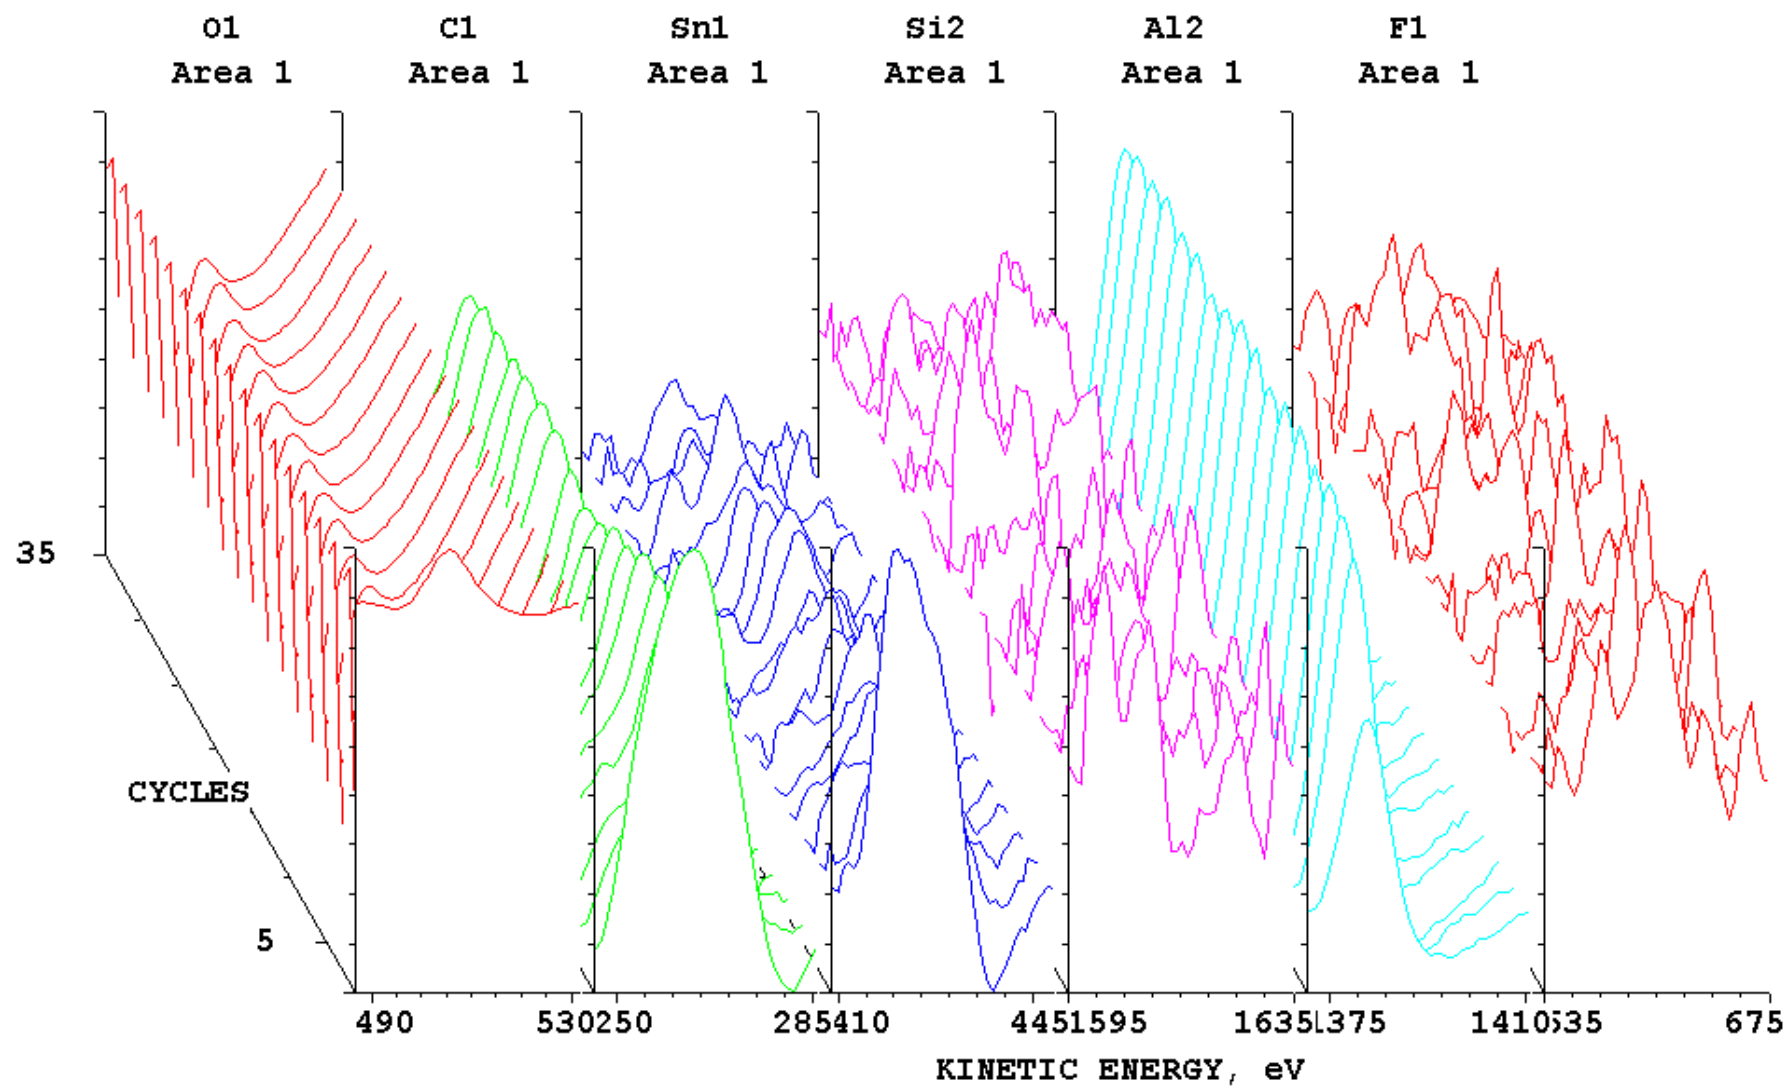
Depth profile done in larger steps, and extended to much greater depth. Still no end to contamination was found.

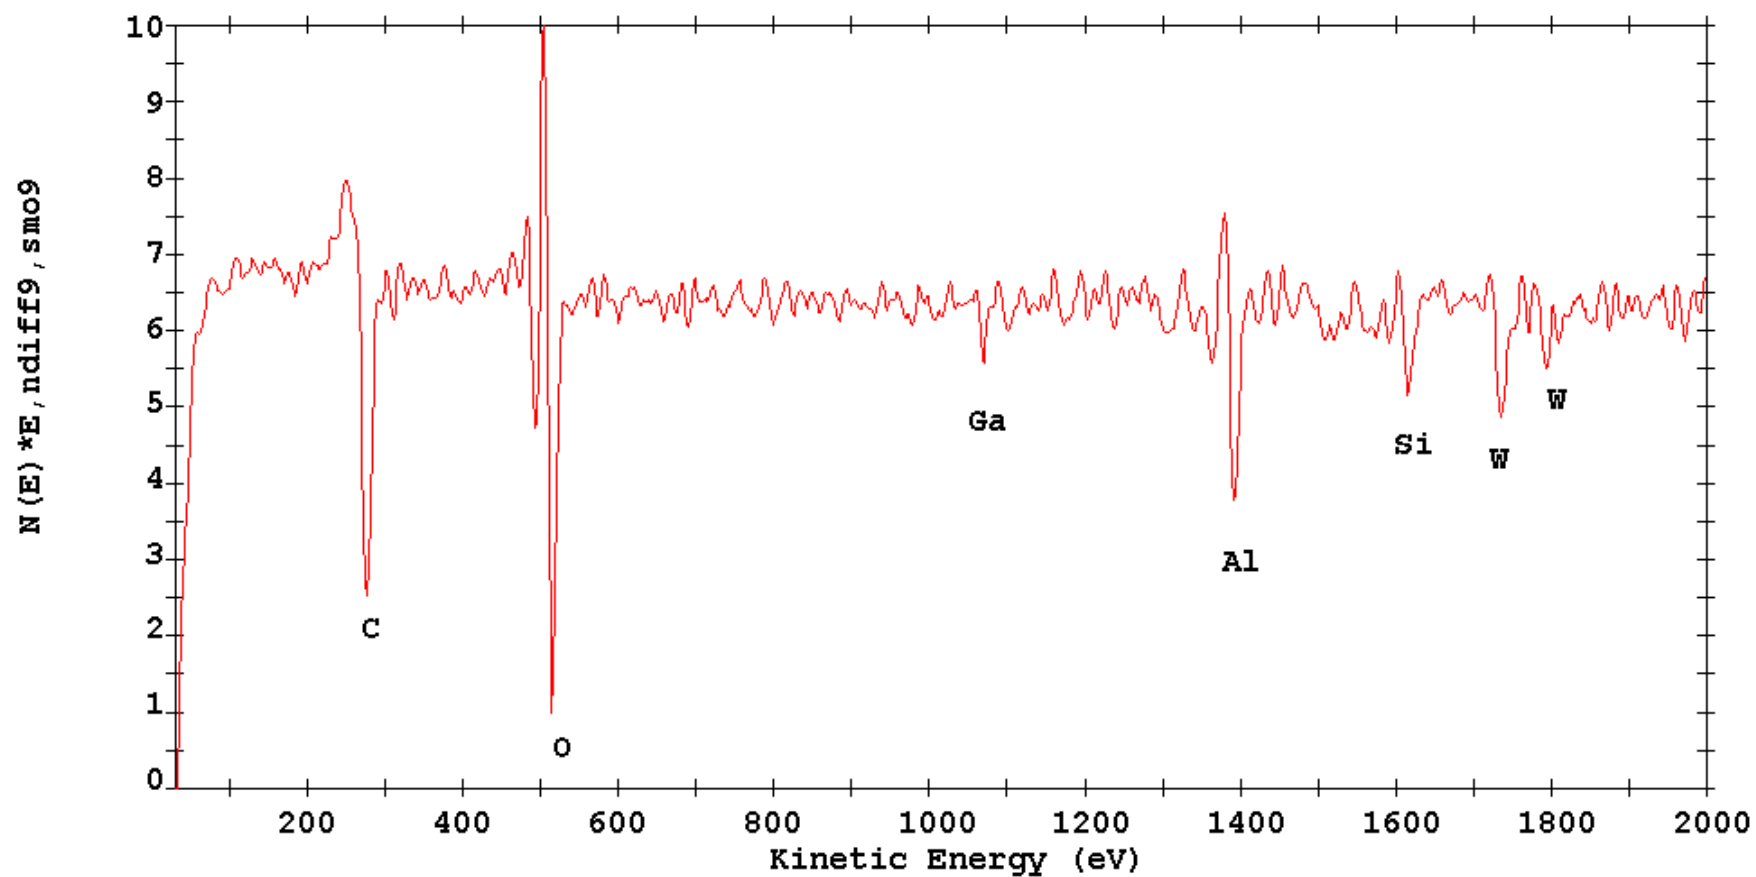
## FIBed Bond Pad on MCM-D Assembly

**Clearly see presence of 3 Al layers in pad.**

- Can clearly see three Al layers present in HP bond-pad, W via material and oxide between layers.
- Carbon/Oxide layer is on top of the upper Al layer, and it is quite thick. It is essentially impossible with this analysis to see the “corner” of this layer and hence measure its thickness (there is no distinguishing feature between the body of the layer and the surface of the layer).
- In the end, the line analyses were quite inconclusive.
- As a final step, another area analysis was done, increasing the sputter cycle step size still further, and extending the depth of the scan.

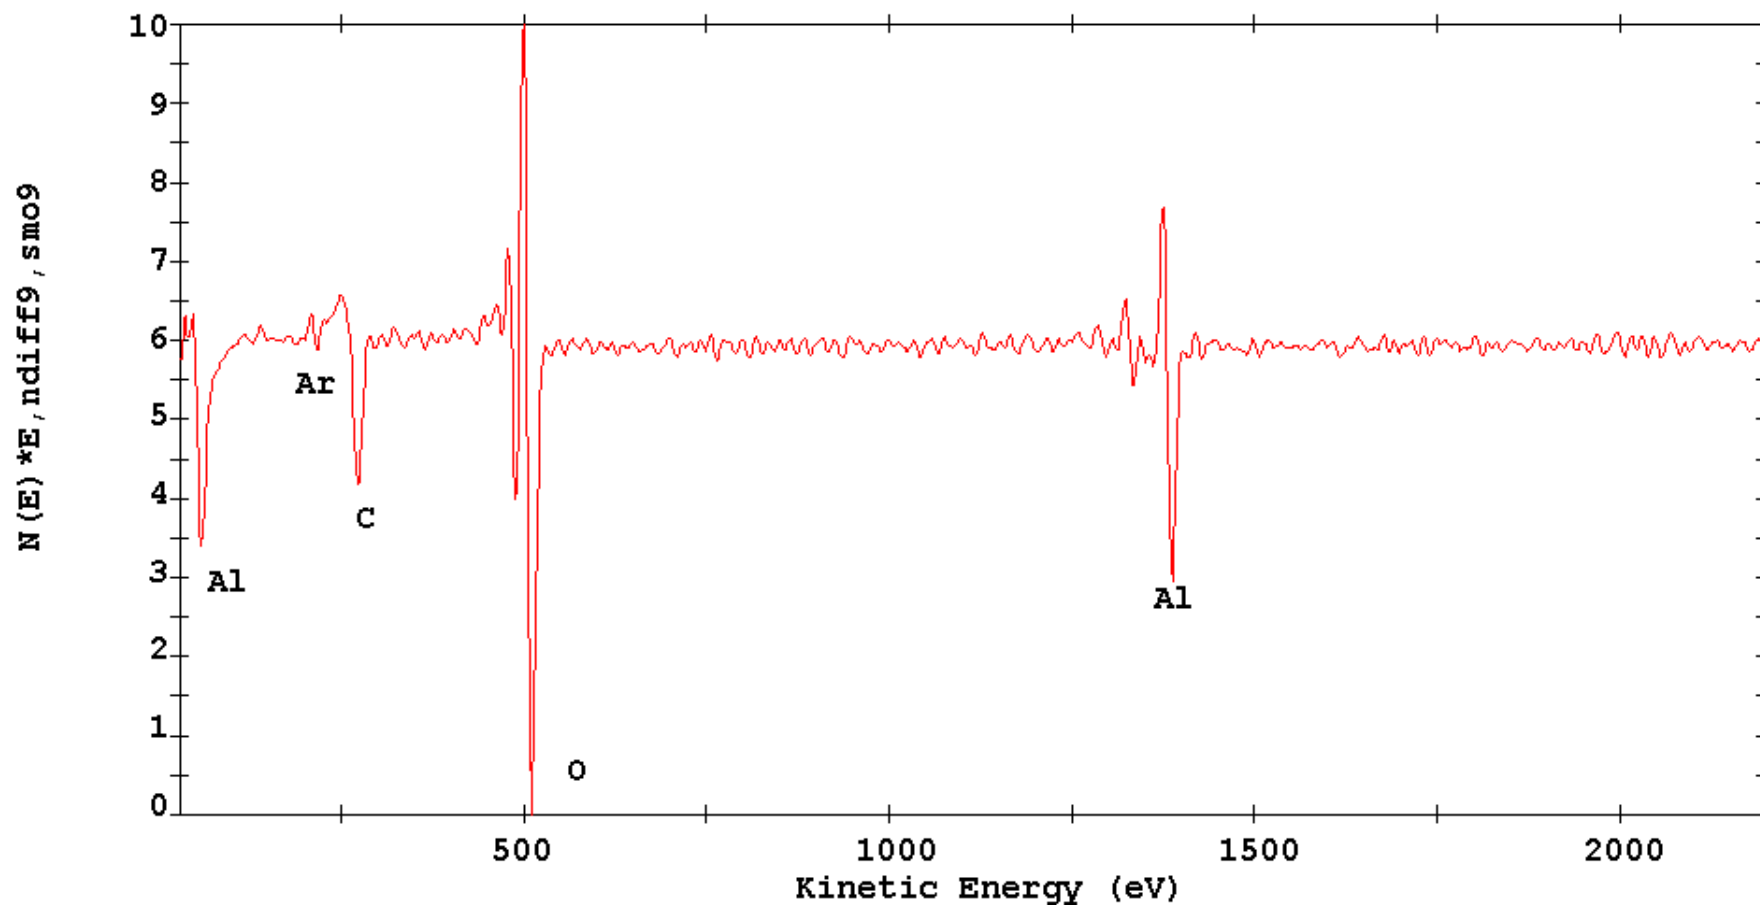
**Perform a final area scan to look for end of contamination layer. Initial survey shown here.**

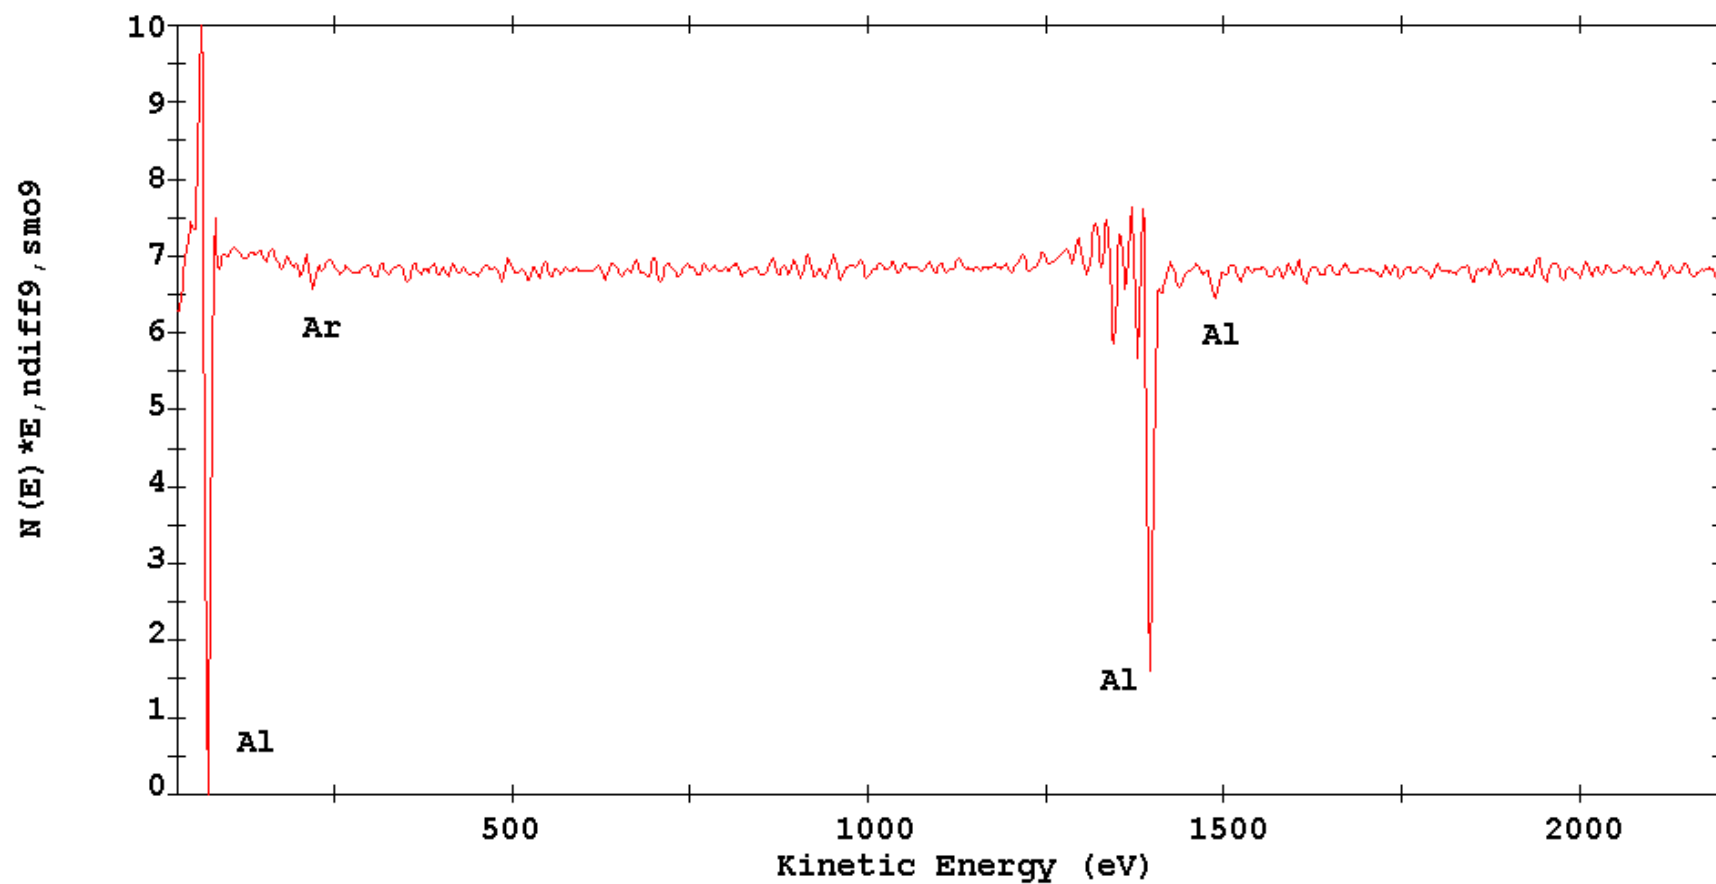
**Spectra show that elemental Al was finally reached.**

- No contamination is seen on the pads prior to bump-deposition.
- Significant organic contamination is present after both the bump-deposition step and the final flip-chip step (there seems to be no obvious difference between the two). The thickness of the contamination layer is difficult to measure because its sputter rate is probably lower than SiO<sub>2</sub>. The expert quoted a range of 600-1500Å, based on his experience with sputter rates.

- The expert was rather astonished that we could bond at all to pads with this level of contamination. Certainly reliability and pull-strength will not be normal under these conditions. Hopefully, after better understanding of the IZM processing steps, modifications to the processing can be made to eliminate this contamination.
